New Discoveries at Islamic Jarash: the mosque, *sûq* and related buildings

*A short report on the 2004 season of the
Danish-Jordanian Islamic Jarash Project*

Site Name: Jarash

Project Name: The Danish-Jordanian
Islamic Jarash Project

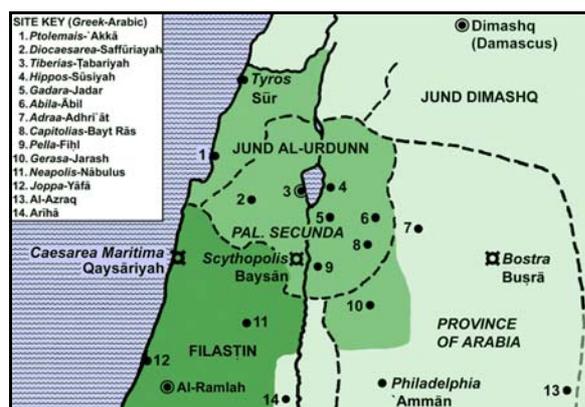
Figure 1: Map showing the Late Antique – Early Islamic administrative divisions affecting Jarash (site 10)

Why should Jarash have a Friday mosque in the Umayyad period? We know that Jarash was a district capital of the *Jund al-Urdunn* (**Figure 1**), and minted both pre-reform and post-reform Umayyad coins. Earlier excavations at different places throughout the antiquities site had revealed a thriving economy in early Islamic times. When considered together this evidence, especially the coins, suggested the presence of an Islamic administration, one which would have required a political and religious centre, focusing on a mosque. This was the building we needed to find to demonstrate conclusively a major Islamic settlement at Jarash, and which was first located in 2002 (**Figure 3**).

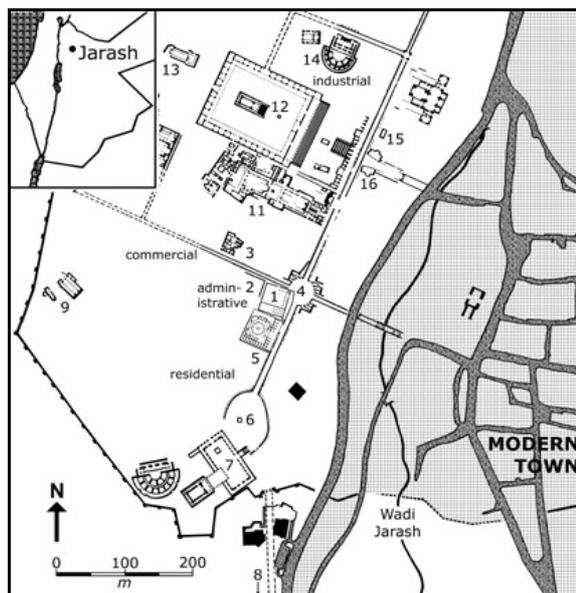
Figure 2: Plan of Jarash in the early Islamic period. The mosque is centrally located at (1).

The discovery of a mosque at Jarash
shows that the Roman and early Chris-
tian town is also an Islamic centre, and
in addition to a Friday mosque, other
important buildings can be expected
(**Figure 2**). The Islamic Jarash Project
seeks to document the Islamic history of
Jarash, in collaboration with the
Department of Antiquities of Jordan.

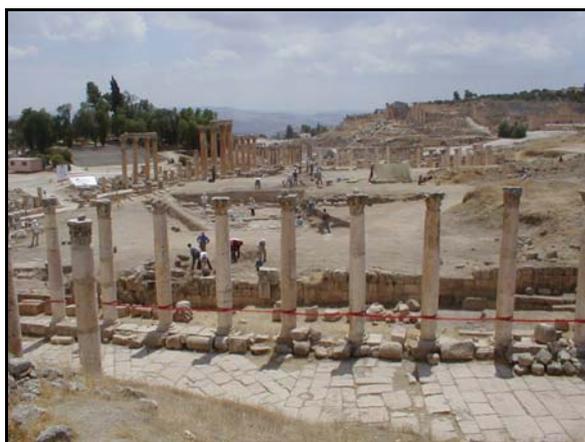
Figure 3: General view of the area southwest of the south Decumanus, beginning of work 2002 (IJP_D006)

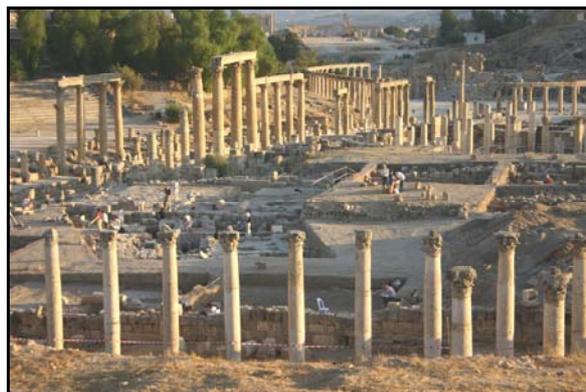
Figure 4: General view of the excavated area of the bath house and mosque, end of season 2004 (IJP_D1323)

This year, our understanding of the mosque has increased enormously (**Figure 4**). Naturally, the arrangement of the building did not work out exactly as expected, and many new problems and questions have been raised. What has become clear is that we are dealing with a building that had a limited life before its destruction, and therefore the Jarash mosque is one of the few existing Umayyad mosques that largely preserves – if a little fragmentarily – its

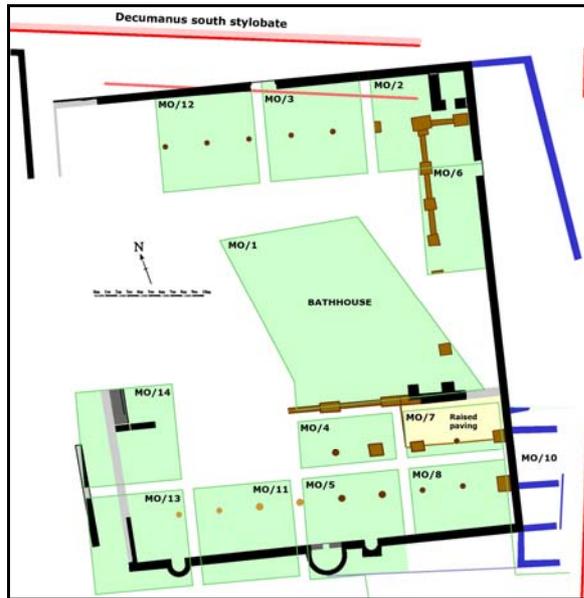
Figure 5: Plan of the mosque, also showing areas excavated (modified from an original by H. Barnes)

A new detailed plan of the mosque was made this year, in which it was revealed that the north (entrance) wall of the mosque, measuring 38.9 m., was constructed well over two metres longer

than the principal qiblah wall, which measures 36.57 m (**Figure 4**). The

difference in wall length explains the irregular axial symmetry of the building between the entrance doorway on the south decumanus and the main mihrab of the mosque. Both the main mihrab and the opposing street entrance doorway are located exactly in the centre of their walls, as they should be, but because of the greater length of the north wall the doorway is offset to the west. As the south, east and north walls lie at right angles, the correction for this irregularity must be in the western wall, as yet largely unexcavated.

of the qiblah wall of the mosque, but align with the lane that ran between the mosque and the macellum along a line drawn from the main mihrab to the south wall of the shops (**Figure 5**).

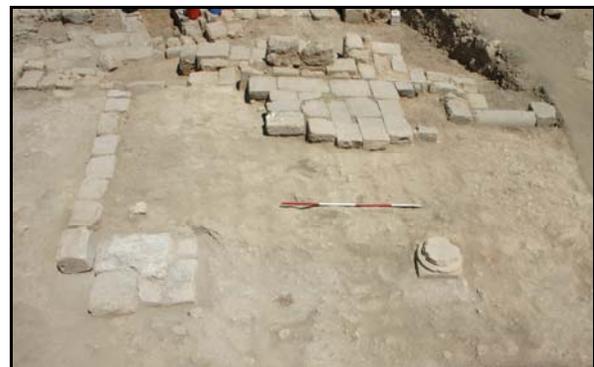
Figure 6: The Raised Platform in the northeast corner of the Prayer Hall. View to north (IJP_D756)

A most interesting and unusual feature is the discovery of evidence for solid walls at either end of the entrance to the prayer hall, at the point where the east and west courtyard porticos join the façade of the prayer hall. They probably helped to support the porticoes, which were also tiled, at their south ends. On the east, the wall was pierced with a doorway, the threshold

of which survives. The doorway led to a raised paved platform area in the northeast section of the prayer hall (**Figure 6**). The purpose of this area is not clear, but perhaps functioned as the *madrasah* of the mosque.

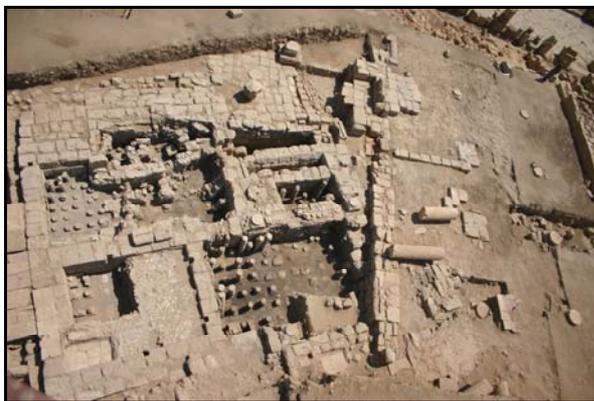
Figure 7: Overview of the bathhouse hypocaust system with the later mosque prayer hall to the right built over the baths (IJP_D1377)

Much effort has been directed at excavating the earlier bath, which occupied the area under investigation before the construction of the mosque. It is now quite clear that the bath had already fallen largely into disuse before the construction of the mosque. Following

the in-filling of the complex's hypocaust system, small basins were constructed in the rooms. These appear to have been for industrial purposes, as the residue from the waste drains suggests. In addition, the entrance piers of the prayer hall were also dug into the hypocaust fill.

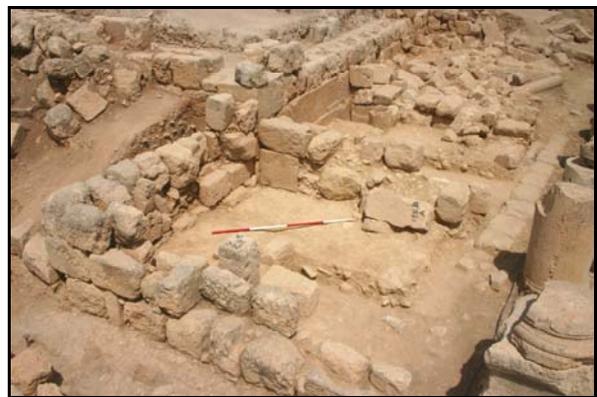
Figure 8: The Cardo shops on the east side of the mosque. View looking northeast (IJP_D1282)

Excavation along the outside of the east wall of the mosque has exposed a row of shops (**Figure 8**). These project south

The shops were built to butt against the mosque's east and south walls, and faced eastwards onto the cardo. Their eastern limits are not preserved, and seem to have been removed when the cardo was cleared in the earlier part of the twentieth century. Built of stone with bright yellow to reddish-yellow clay floors, the shops appear to have had a very short life before their destruction. An earthquake is the most likely cause — perhaps the devastating one of 749 CE — as the extensive stone tumble from the mosque south of the qiblah wall also suggests (**Figure 9**).

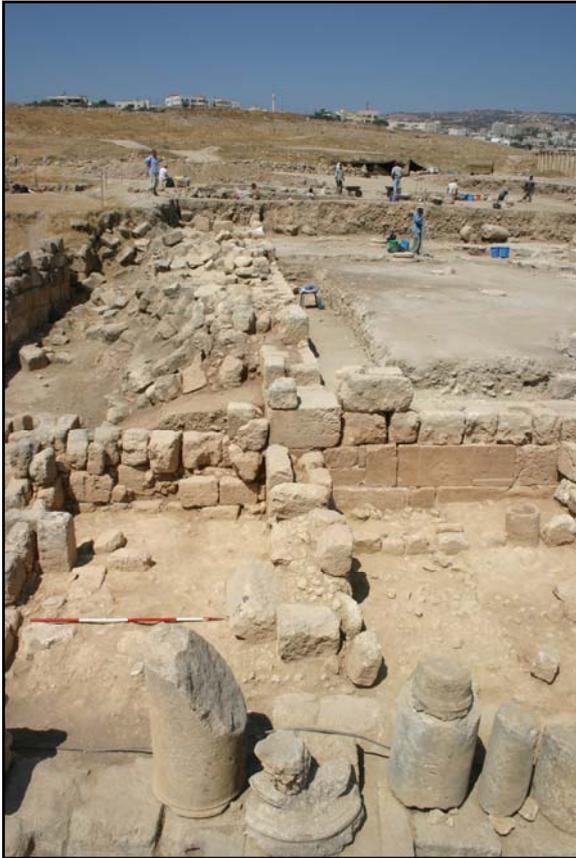
Figure 9: A long view to the south of the mosque, looking west, showing a section of the shops in the foreground with, behind, the stone collapse of the qiblah wall (IJP_D945)
